**An Assessment of Trails, Watercourses, Soils, and Redwood  
Forest Health in Joaquin Miller Park, Oakland, California,  
with Recommendations for Management**

City of Oakland  
Office of Parks and Recreation  
1520 Lakeside Drive  
Oakland, California 94612

Richard D. Koehler and Janet M. Sowers  
William Lettis & Associates, Inc.  
1777 Botelho Dr., Suite 262  
Walnut Creek, CA 94596

December 31, 2000

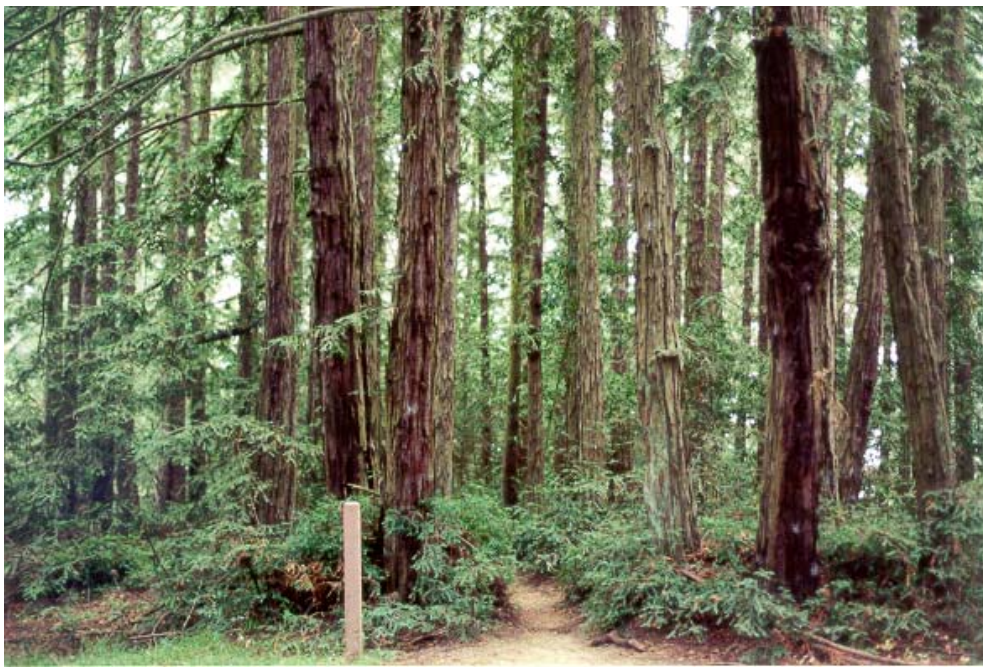
**Figure 2:** Area “I” of the Big Trees Trail, Harsh Growing Site

Although these trees are smaller on average than other trees of the Park, they are the same age as the other larger redwood trees. This area shows a lower overall tree vigor because it is a harsher growing site, probably due in part to shallower soils, not due to any Park use.

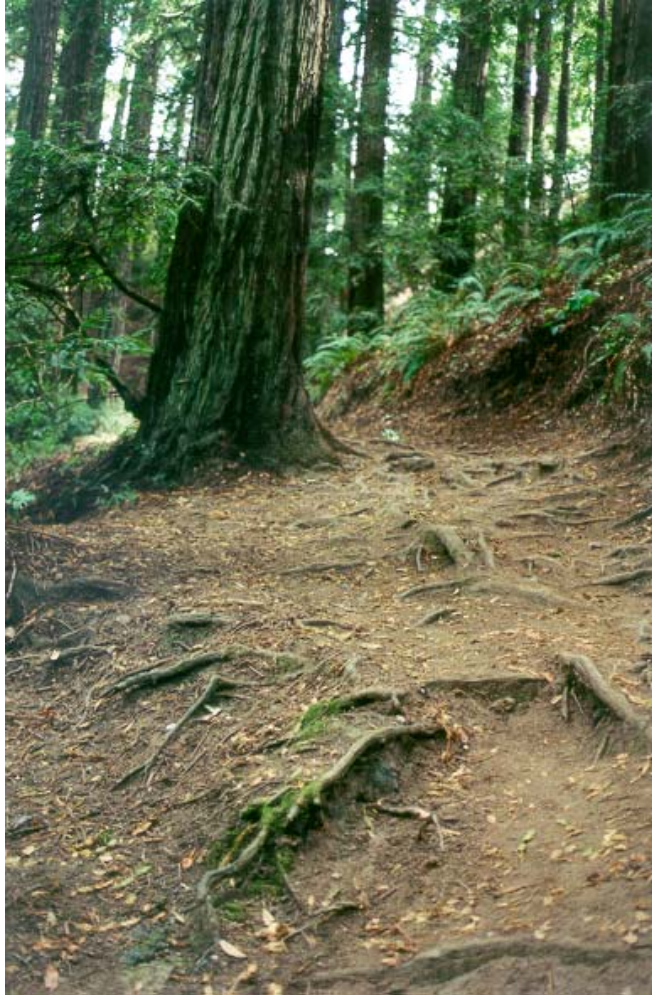
**Figure 3:** Area “K” of the Big Trees Trail west of Sequoia Point

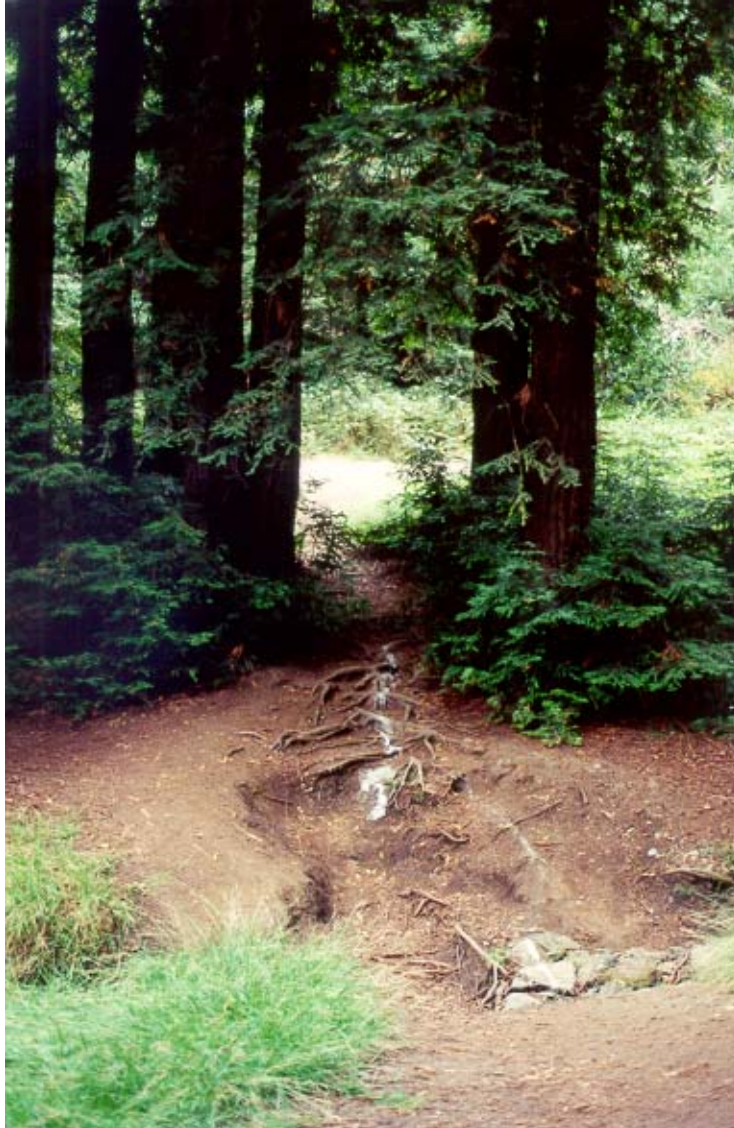
**Figure 4:** Area "K" of the Big Trees Trail at Junction of Sunset Trail

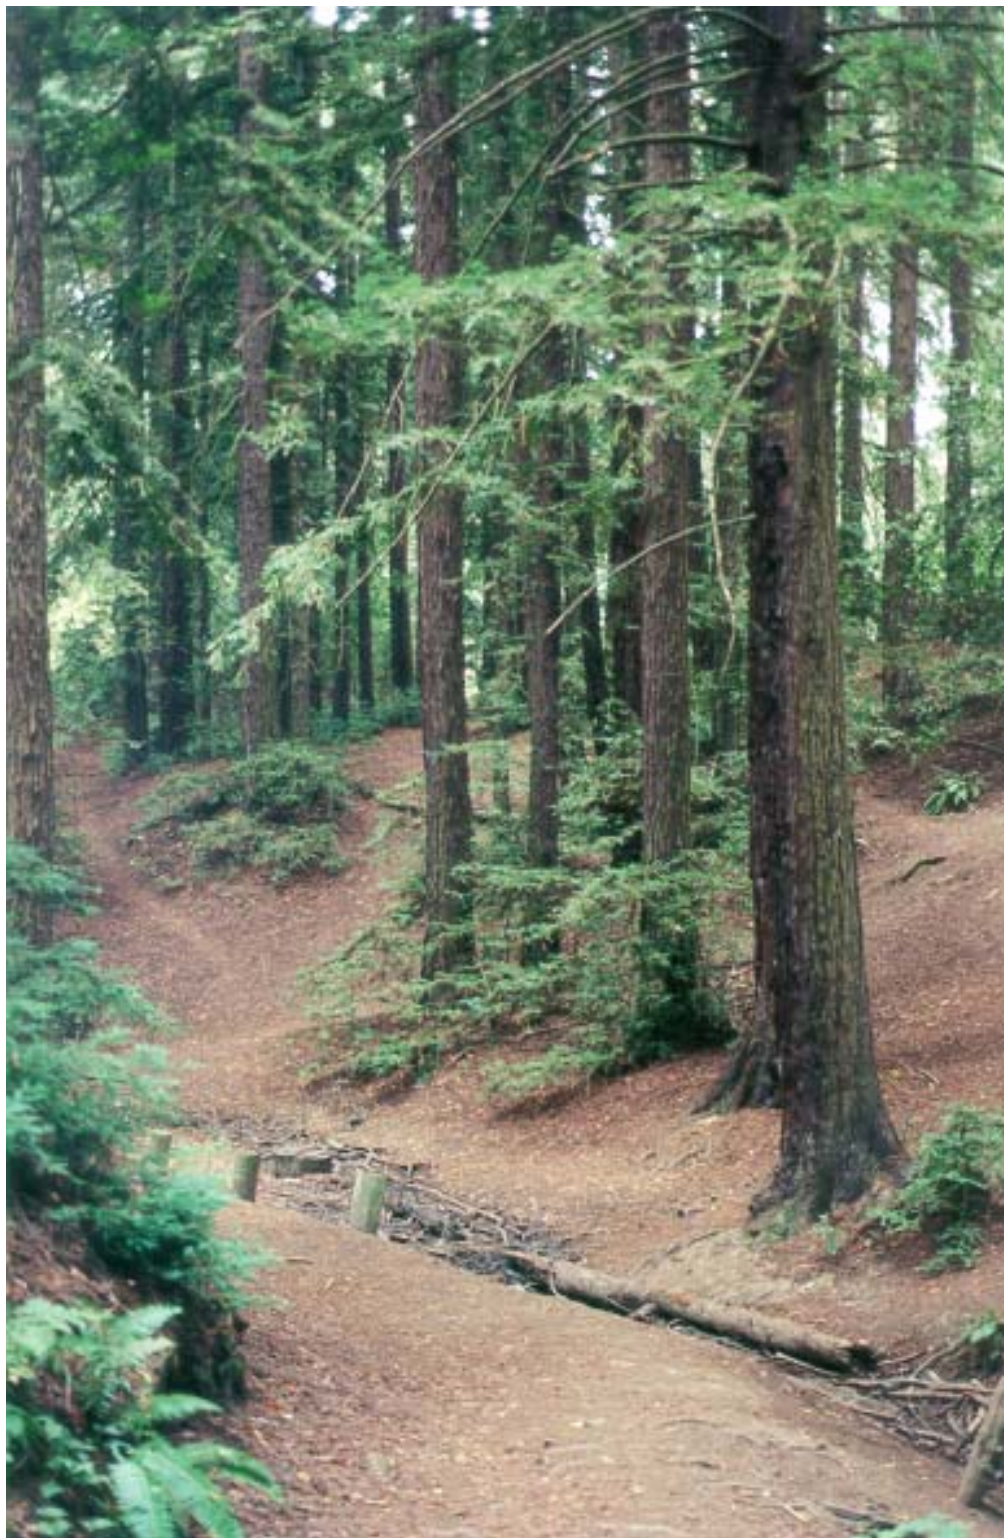
species diversity and native plant components. The vegetation trampling results from all types of off-trail traffic (pedestrian, equestrian, and bicycle) with no distinct difference in degree of impact between the types of off-trail traffic. The off-trail traffic causes direct physical impact to the plants as well as soil compaction, which can be a limiting factor for plants (especially the liliaceous species). Off-trail use was noted throughout the trail system. In particular, the flat and gentle slope areas, such as the ridgeline and spur ridges associated with the Ravine and Big Trees trail areas, were heavily impacted (see Figure 5).

**Figure 5:** Off-Trail Vegetation Trampling Impacts in the Redwood Forest (Ravine trail area).

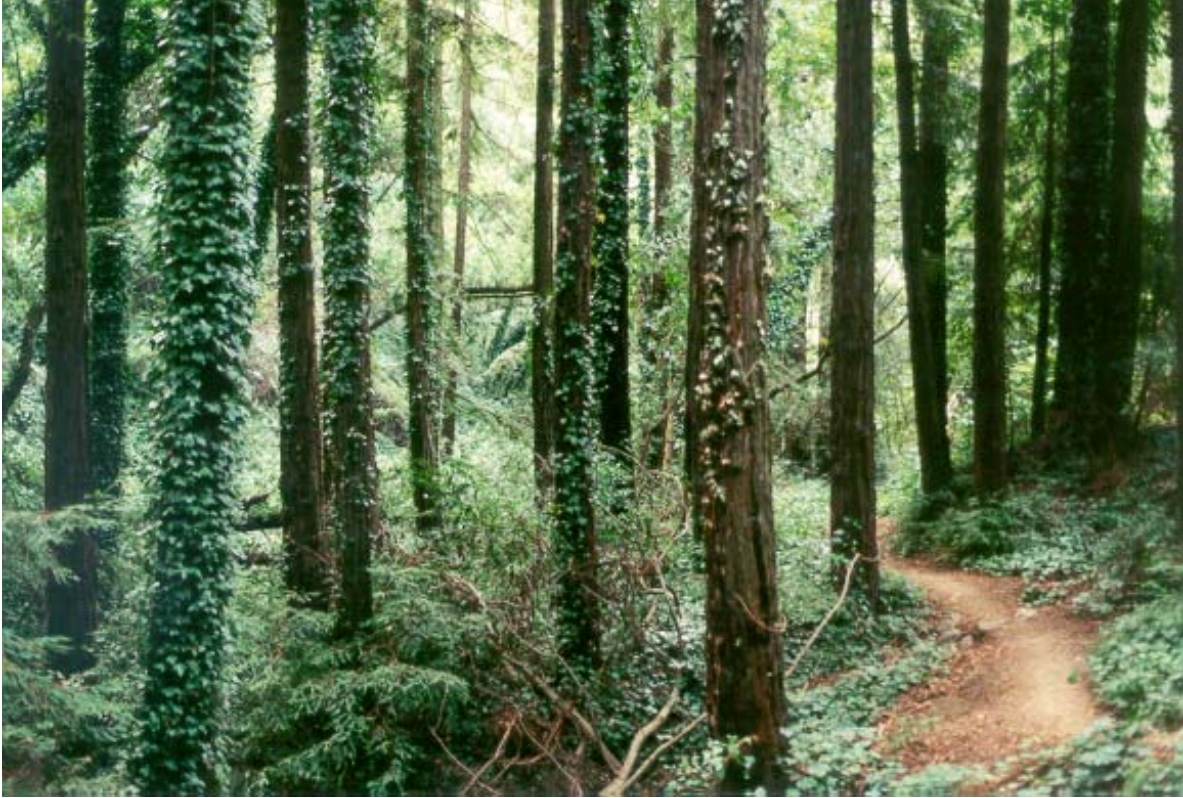
**Figure 6:** English ivy climbing redwood trees (along Palo Seco Creek).

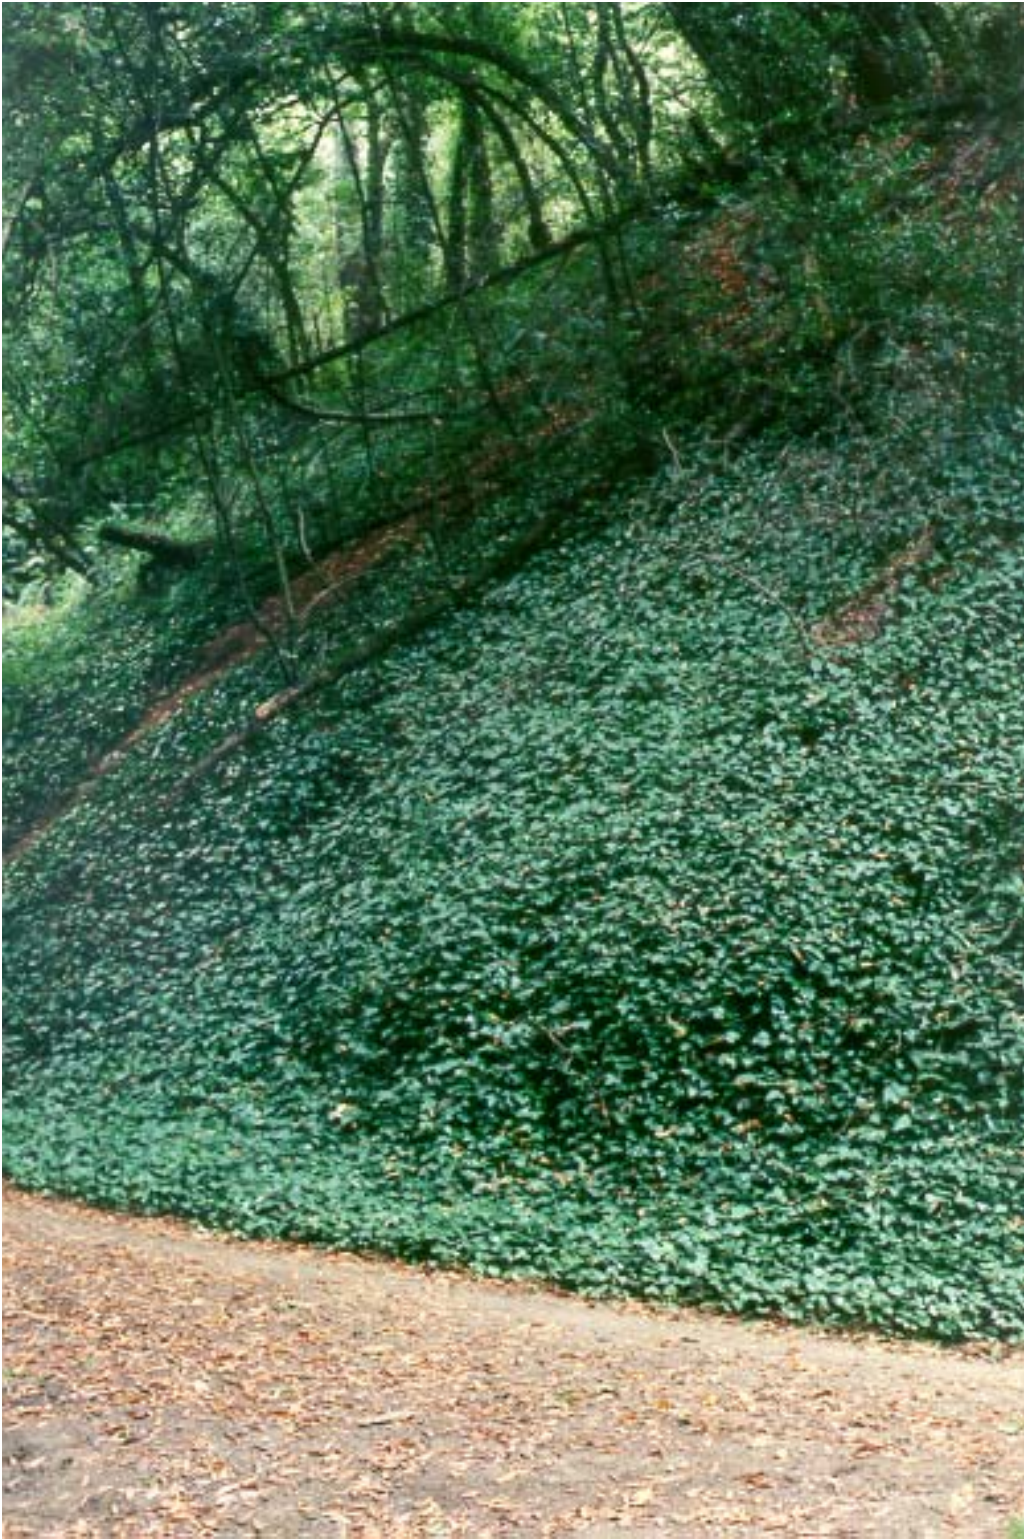
**Figure 7:** English ivy carpeting and smothering the herbaceous layer (along Palo Seco Creek).
