BEACONSFIELD CANYON PRELIMINARY CREEK RESTORATION PLAN

15 April 2010

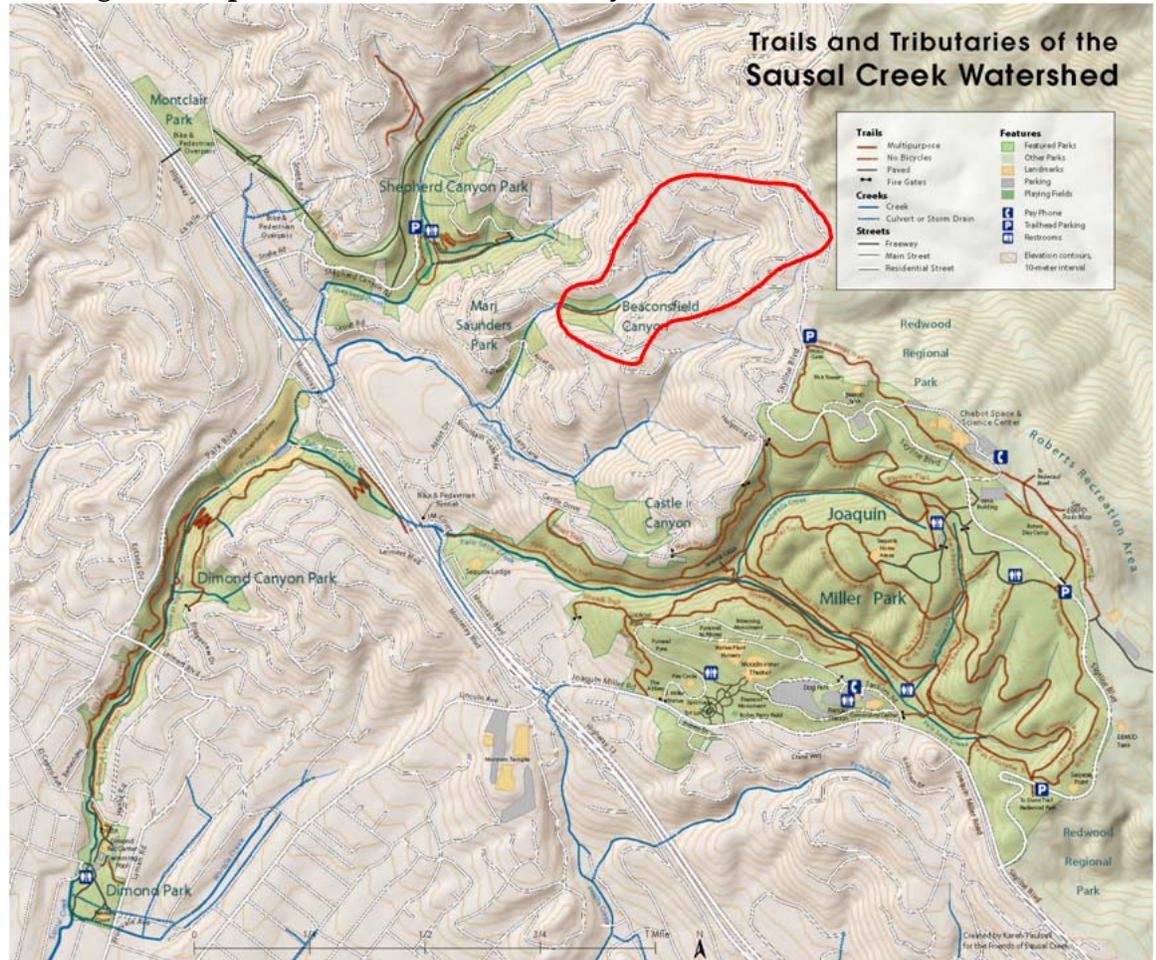
Drainage Area Upstream of Beaconsfield Canyon

Cottonwood Creek in Beaconsfield Canyon drains approximately 0.13 square miles or 80 acres from a high point of approximately 1,500 feet to a low point at the storm drain inlet of approximately 950 feet (See map below). The watershed above Beaconsfield Canyon

is primarily single family residences, roads, and culverted stream crossings. Average precipitation in the area is 28 inches per year.

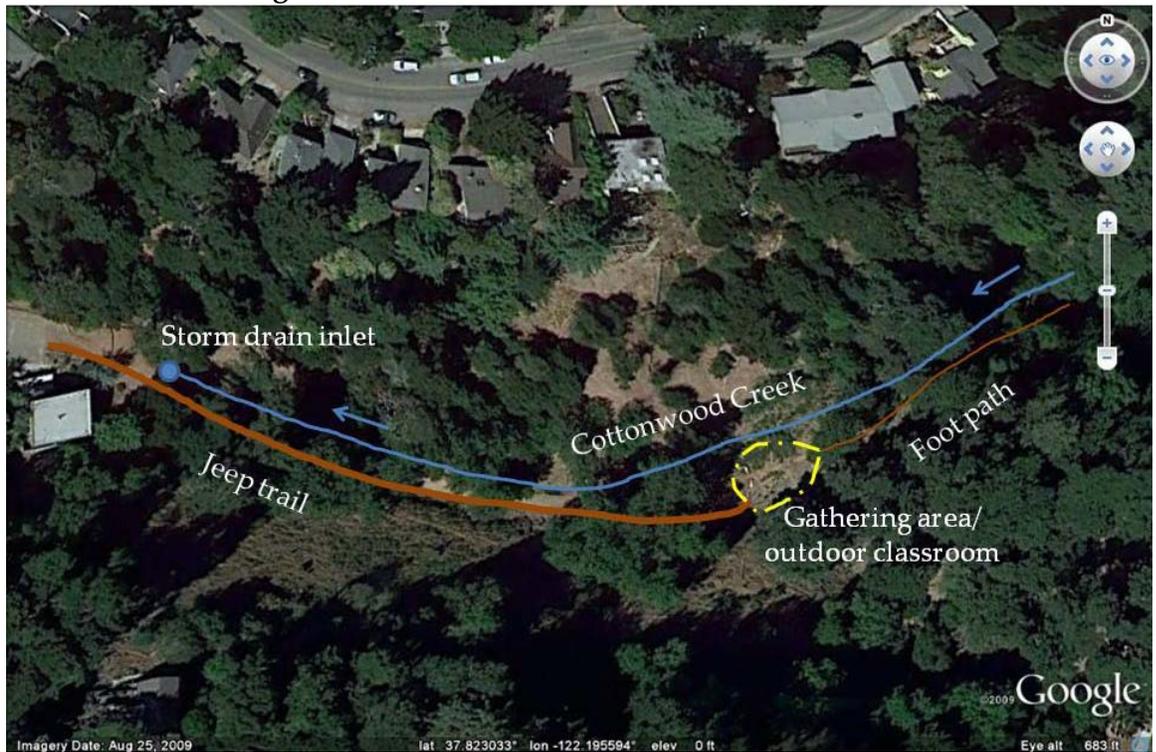
Schematic of Existing Site Features

The downstream end of the project reach is an eroding storm drain inlet. The project reach extends upstream approximately 500 feet to the point where the canyon narrows.

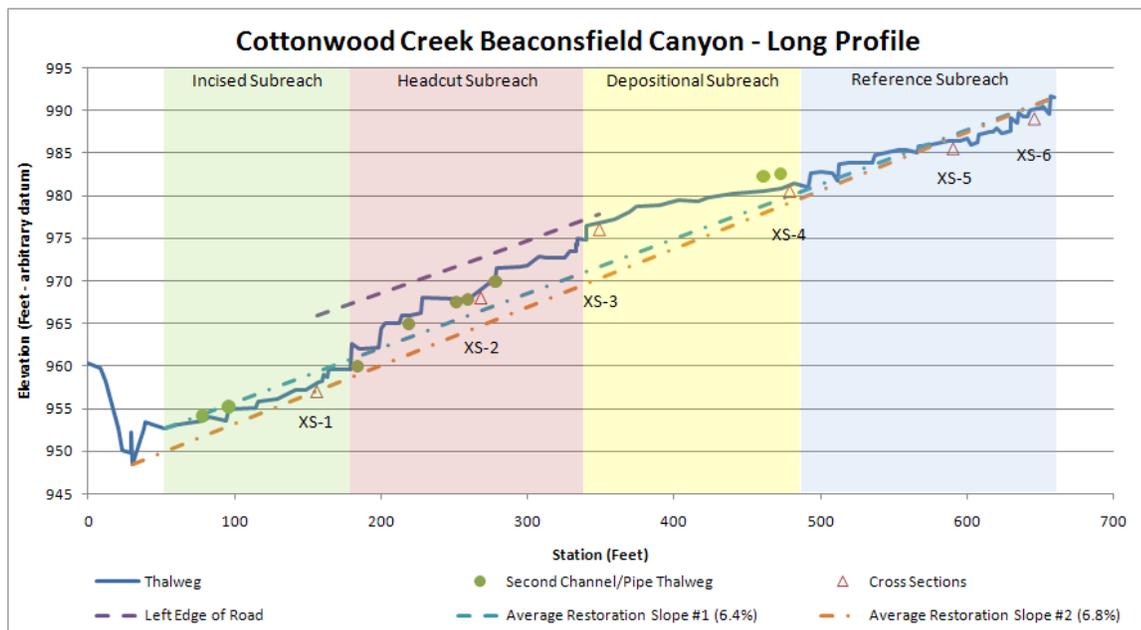
Longitudinal Profile

The figure below displays the results of the longitudinal profile through both the project reach and the reference reach that extends upstream.

The average slope of the surveyed profile from the most upstream point of the survey to the end of the defined channel (approximately 20 feet upstream from the storm drain inlet) is 6.4%.

The surveyed profile can be divided into four subreaches: (upstream to downstream) reference; depositional; headcut¹; and incised.

The **reference subreach** extends from the upstream extend of the survey (6+60) to the point at which the canyon widens slightly (4+82). The subreach is characterized by in-channel woody debris, root structures, and vegetation that provide habitat structure and a step pool sequence. The average slope through the reference reach is 5.6%.

The **depositional subreach** extends from the widening of the canyon (4+82) to the first major headcut (3+40). The depositional reach is characterized by a flat depositional area with little to no large woody debris. The depositional feature begins where the stream debauches from the confined canyon. The widening of the canyon and the diversion of some of the water into a storm pipe reduce the creek's capacity to transport sediment. Through the lower half of the subreach the channel is poorly defined. The average slope through the depositional reach is 3.6%.

The **headcut subreach** is by far the steepest in the project area. It extends from the location of the most upstream headcut (3+40) to the most downstream major headcut (1+79). Average slope through the headcut reach is 11%. The subreach is characterized by a series of headcuts migrating upstream and reworking the foot of the canyon depositional feature. The reach is vegetated by black cottonwoods. These cottonwoods provide some stability but some are leaning severely suggesting that the headcuts are undermining the roots of the trees. The subreach is also characterized by a bi-furcated channel and rusty storm pipe that complicate channel formation and stability.

The **incised subreach** extends from the base of the most downstream of the major headcuts to the flood berm just beyond the storm drain inlet. The reach is characterized by a reduction in slope and a channel that runs alongside an abandoned storm pipe and other remnant infrastructure, such as a concrete “wall”. The defined channel ends approximately 20 feet before the storm drain inlet. The inlet is deteriorating (see photo below).

The second destabilizing factor is the large depositional feature in the middle of the surveyed reach. This is most easily recognized in the longitudinal profile as the “hump” that extends above the line labeled ARS #1 and extends between the depositional subreach and the headcut subreach.

Average restoration slopes #1 and #2 on the longitudinal profile represent two options for creek restoration. Average restoration slope #1 (ARS #1) represents the average slope between the top of the survey area and the downstream end of the defined channel. The downstream elevation is roughly equivalent to the storm drain inlet elevation. ARS #1 is the stream gradient toward which the stream has been adjusting since the inlet was installed.

Average restoration slope #2 is the average slope between the top of the survey and the invert of the downstream storm drain inlet (approximately 4 feet lower than the downstream elevation for ARS #1). ARS #2 is probably closer to the creek's natural average gradient prior to the installation of the storm drain inlet. Given the deterioration of the storm drain inlet, it may be wise to design a creek restoration that ties into the lower elevation (ARS #2).

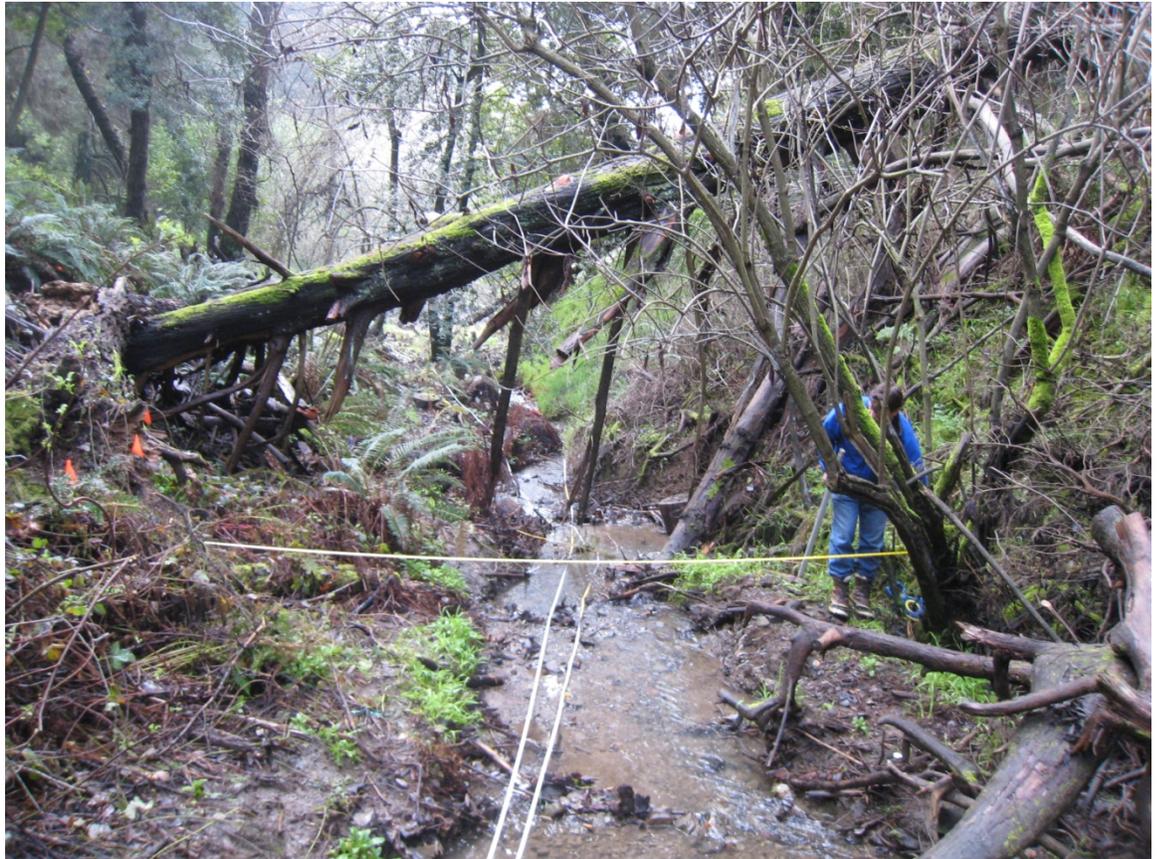
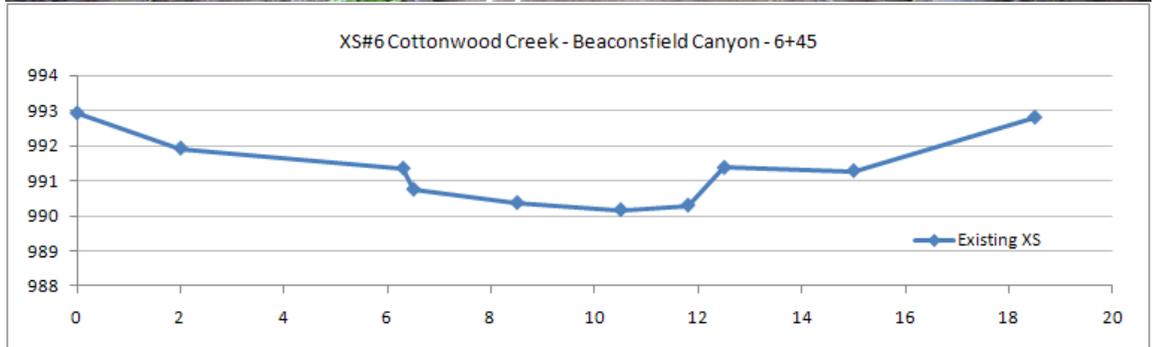
Cross Section #6 – 6+45 (Reference Subreach)

Cross section #6 is the upstream most cross section in the surveyed reach. It and cross section #5 serve as references for cross sections #1-#4 in the project reach further downstream.

The local stream gradient is 8%. The bankfull channel at cross section #6 is approximately 6 feet wide by 1 foot deep with a cross-sectional area of 5.7 square feet.

An abundance of in-channel woody debris serves as both structural habitat and grade control creating a step pool sequence through the subreach.

The bankfull cross sectional areas for reference cross sections #6 and #5 are 5.7 and 5.6 square feet respectively. The bankfull widths vary between 4 and 6 feet wide and the bankfull depths are between 1 and 1.5 feet deep. Downstream in the project reach, the drainage area is slightly larger. Designing bankfull channels that are slightly oversized is advisable as it allows the restored channel to capture passing sediment and form its own channel. For this preliminary restoration plan, we have sized the restoration cross sections at approximately 6 feet wide by 1.5 feet deep with bank slopes of 1:1. Width to depth ratios will vary in final design based on the cross sections relative location in any given step-pool. For example, cross sections near the base of the step will be deeper and cross sections near the top of the step will be shallower. The preliminary dimensions given here are mostly for the benefit of calculating excavation and off haul amounts.

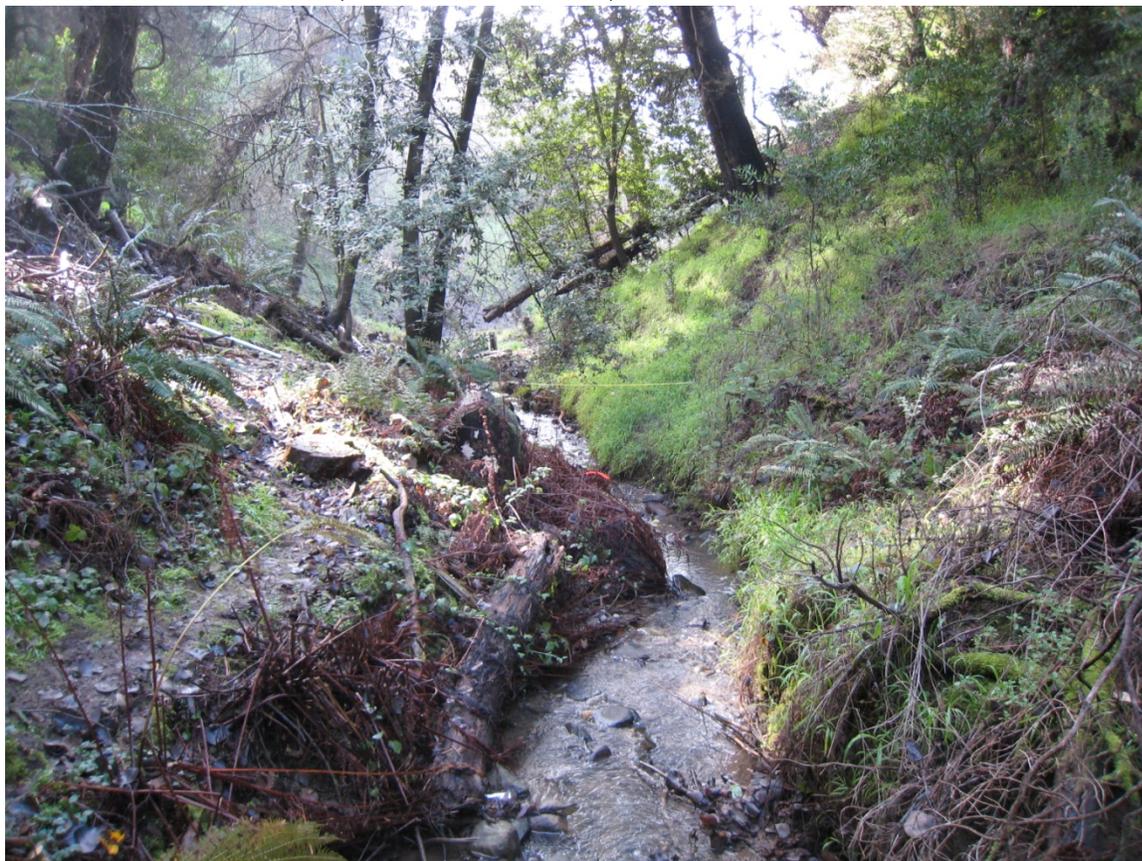
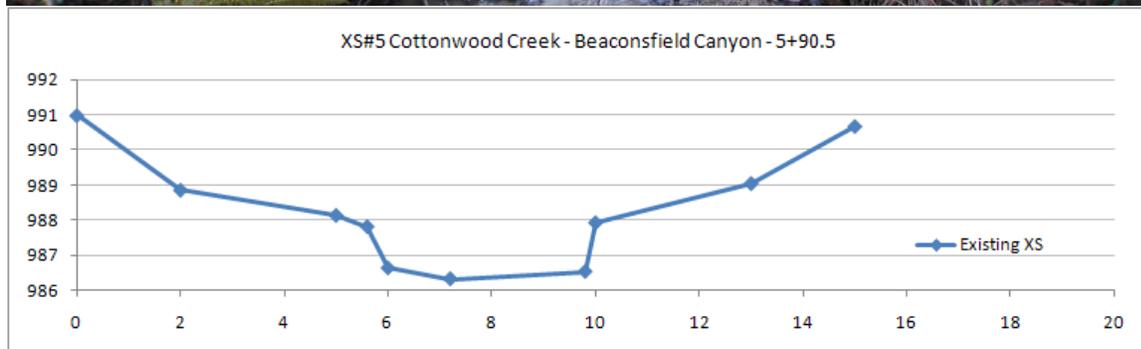
Cross Section #5 – 5+90.5 (Reference Subreach)

Cross section #5 is upstream of the project reach. The local stream gradient is approximately 3.9% and the canyon is slightly more confined than the downstream project reach. The bankfull channel is a little less than 4 feet x 1.5 feet with a cross sectional area of 5.6 square feet. The reach is characterized by a step-pool/plane bed sequence and in-channel vegetation and large sediment providing grade control.

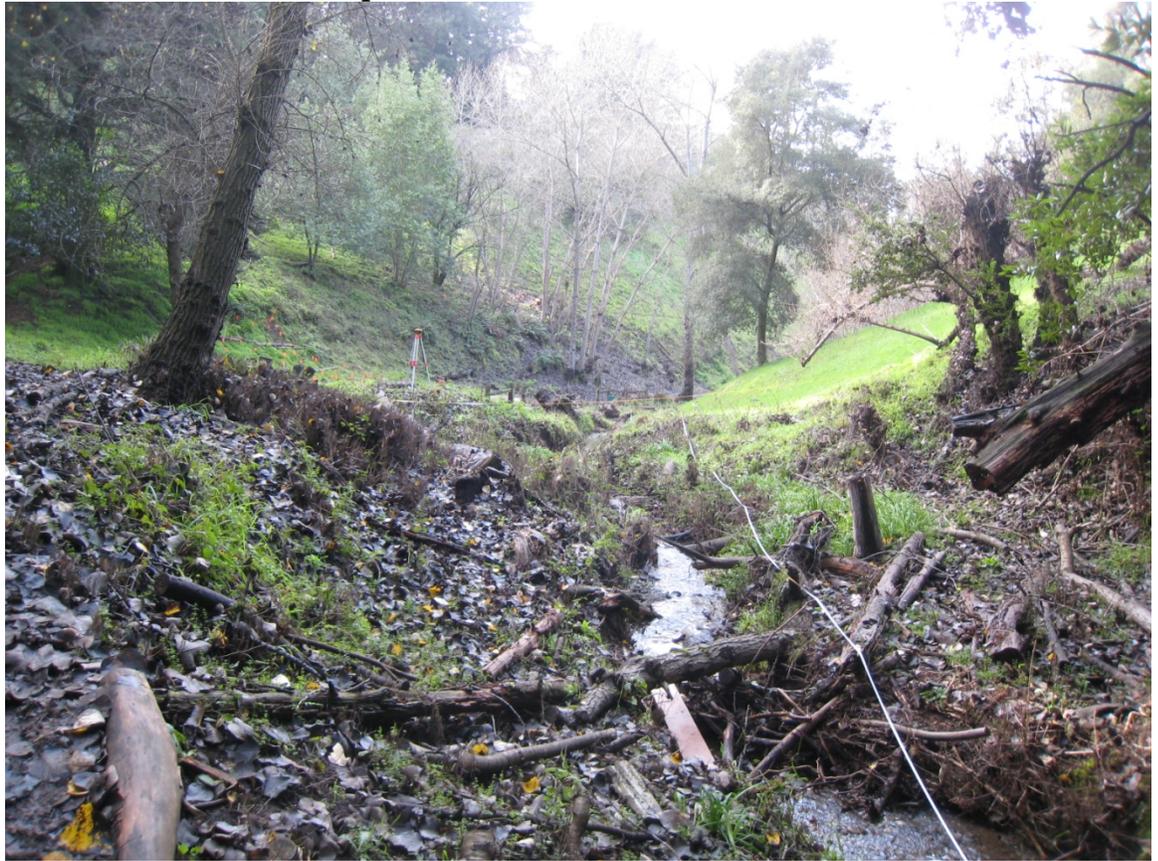
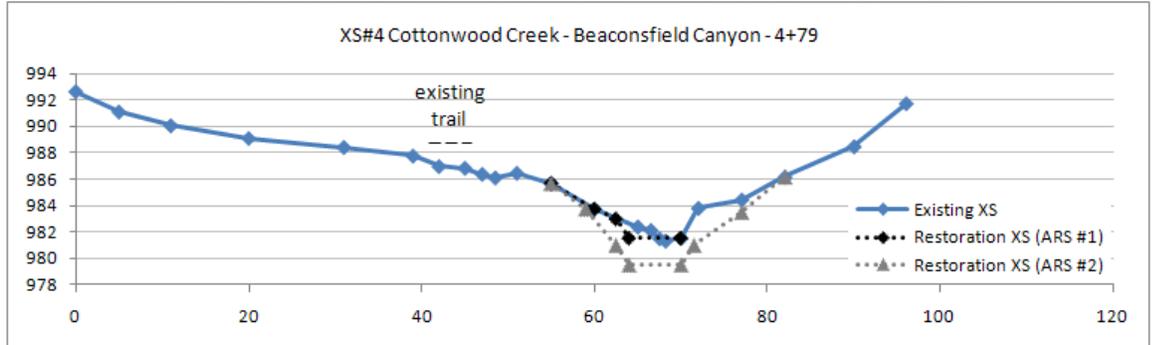
Cross Section #4 – 4+79 (Depositional Subreach)

Cross section #4 is at the upstream end of the project reach and immediately downstream of the reference subreach. Cross section #4 is at the upstream end of the relatively gradual depositional subreach (3.6%). The left side of the surveyed cross section is a small, intermittent tributary that drains a southern sub-basin of Beaconsfield Canyon. The abandoned storm pipe remains along the right side of the channel, diverting water. No trees grow along the channel.

RDG surveyed four cross sections in the project reach. Included in the plots are restoration cross-sections labeled ARS #1 and ARS #2. The restoration cross-sections are included to assist in determining the amount of excavation and off-haul required to restore the creek to a more natural gradient (discussed later). The actual restored cross-sections will be much more complex and determined in later stages of design.

The restoration cross sections above are drawn directly below the existing cross sections. Further design will place these cross sections laterally (left and right) so that they preserve the trail, avoid destabilizing the canyon slopes, achieve the desired stream gradient, and, if necessary, accommodate the existing sewer line or other infrastructure.

The biggest cost in most creek restoration projects is usually excavation and off-haul. Cross sections 1-4 above show restored cross sections at both average restoration slopes (6.4% and 6.8%). Cross sections 2 and 3 would require the most excavation to reach the equilibrium slope. Cross section 2 would require 1.5-2.5 cubic yards per linear foot of excavation. Cross section 3 would require 3-4.5 cubic yards per linear foot. The range is dependent on which average restoration slope is selected.

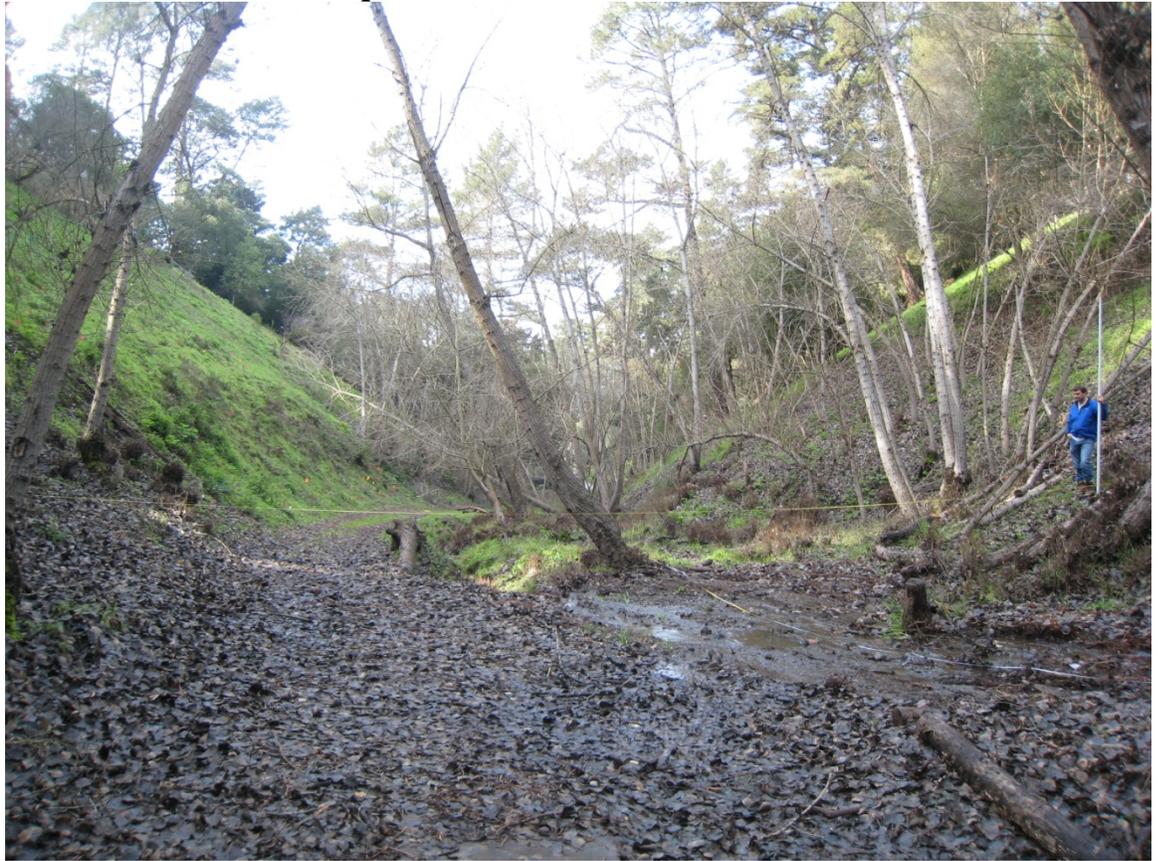
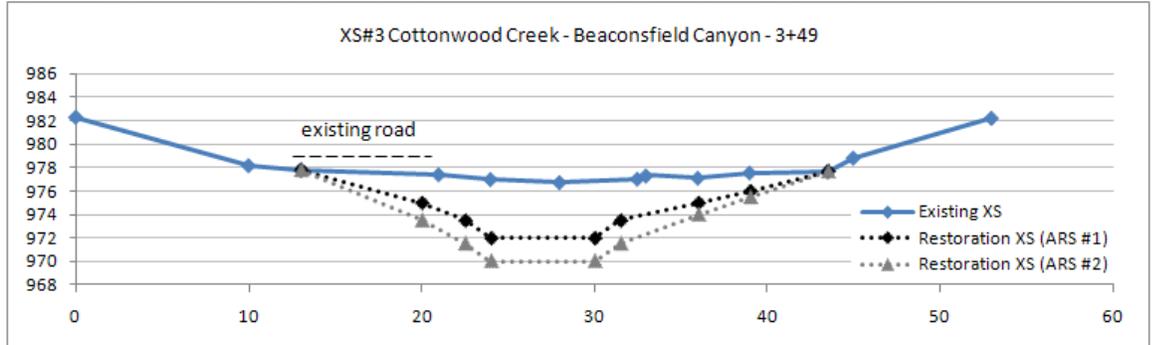
Cross Section #3 – 3+49 (Depositional Subreach)

Cross section #3 is at the downstream end of a relatively flat subreach. The local slope is 3.6%; the least steep of all reaches in the surveyed profile. The channel is poorly defined and characterized by multiple, small distributary channels, common in streams with excess sediment deposition. No trees grow along the channel or floodplain.

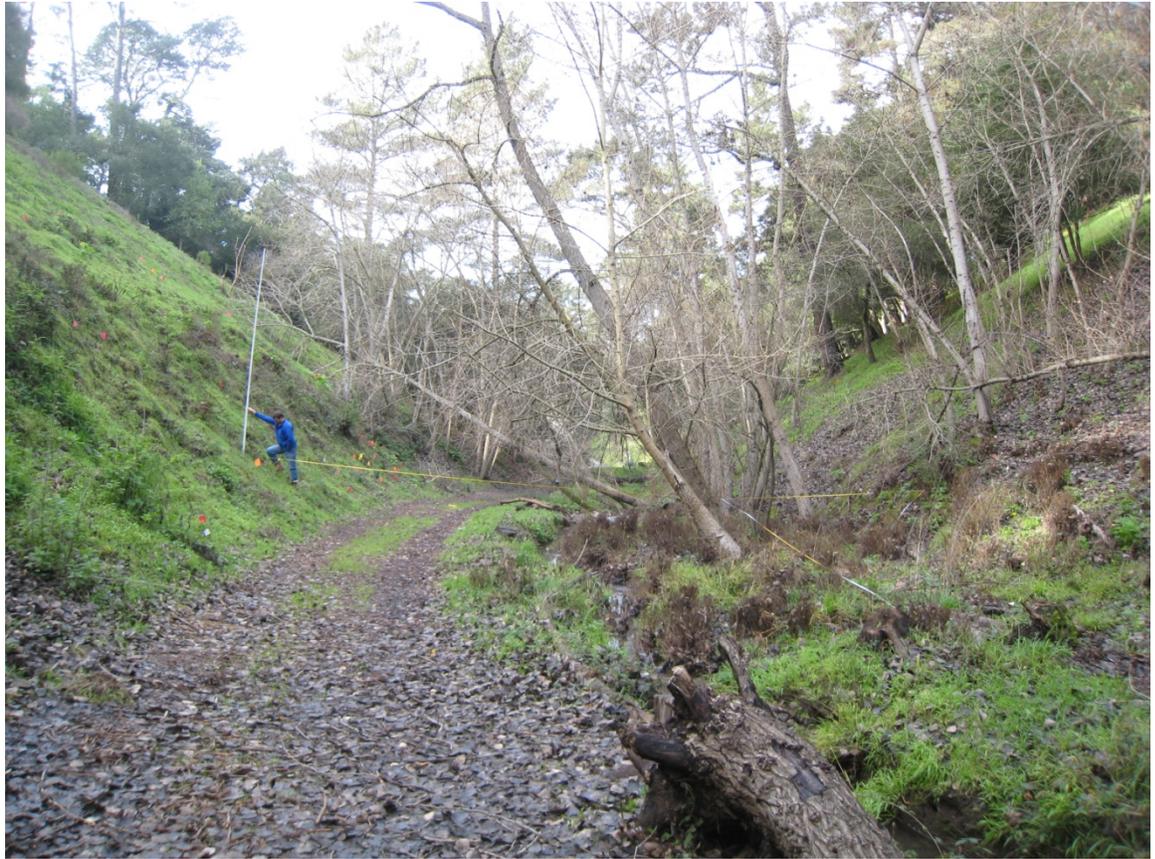
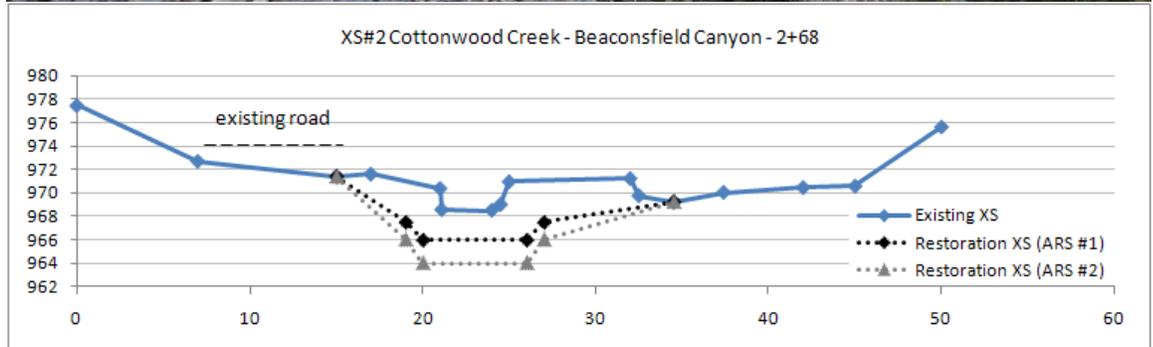
Cross Section #2 – 2+68 (Headcut Subreach)

Cross section #2 occurs in the steepest subreach of the surveyed profile. The local slope through this subreach is almost 11%. The subreach is characterized by steep headcuts, a bi-furcated channel and exposed storm pipe. Black cottonwoods grow between the two channels and on the right bank. Some of the cottonwoods lean over the channel suggesting that the channel erosion is undermining tree stability. The steep headcuts indicate that the creek is actively re-working and eroding into the depositional feature that occupies the canyon floor.

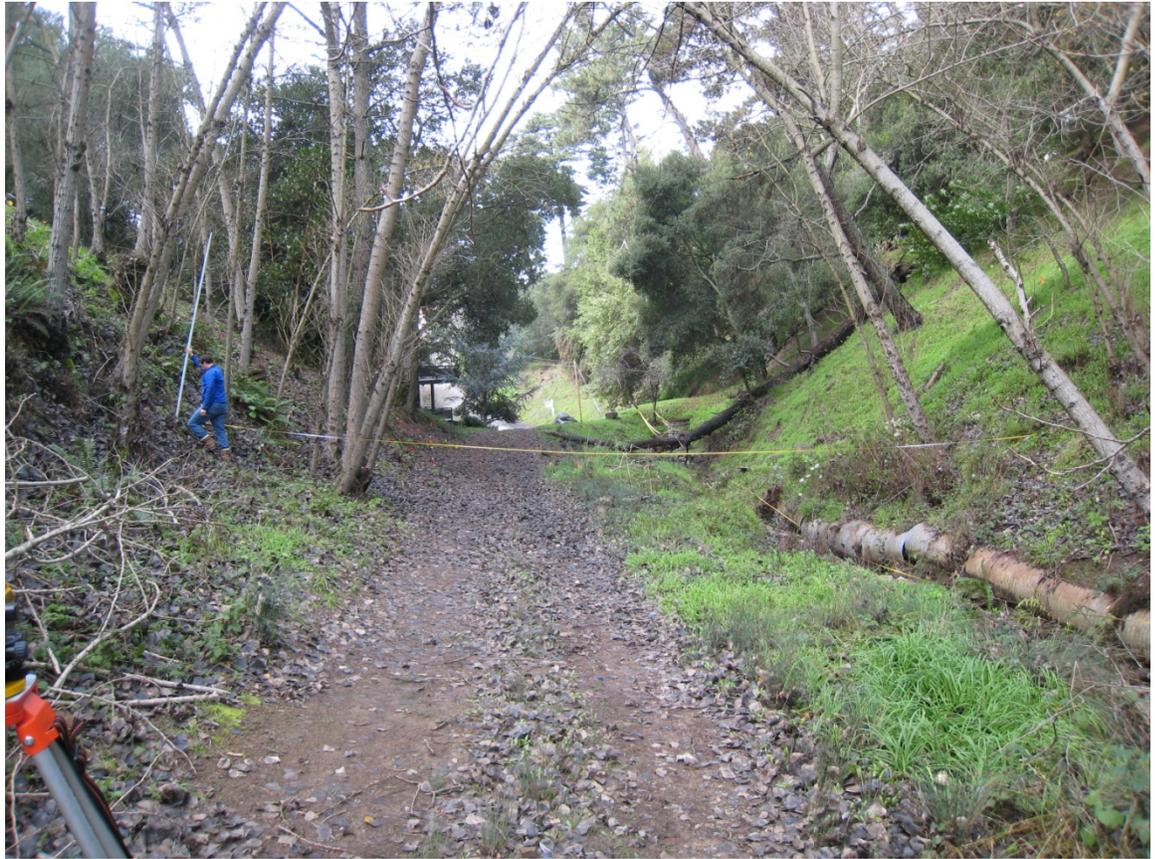
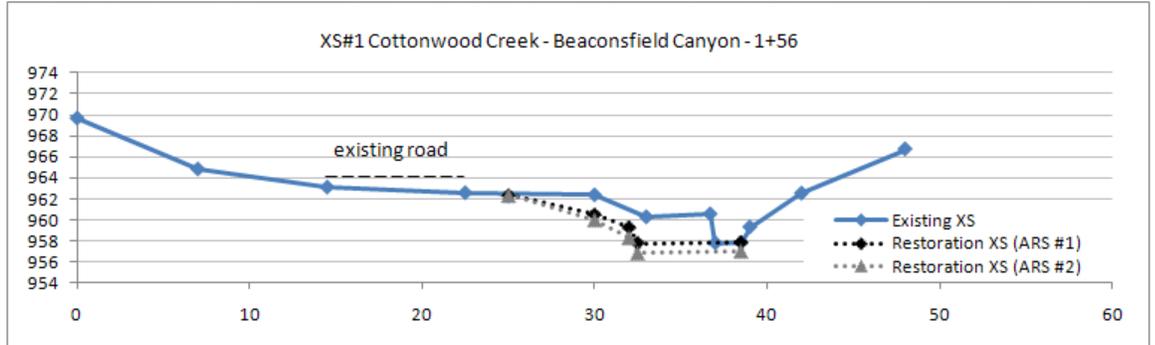
Cross Section #1 – 1+56 (Lower subreach)

Cross section #1 is the lowest of the six cross sections. A small concrete “wall” forms the left bank of the low flow channel. A disconnected storm pipe is imbedded into the right bank. Trees grow on the hill slopes but not in the channel or floodplain. The localized slope is 5%, less than the average slope for the entire surveyed profile.

It appears that cross section #1 is in a subreach of creek where the channel has eroded through the excess deposition in the canyon floor.

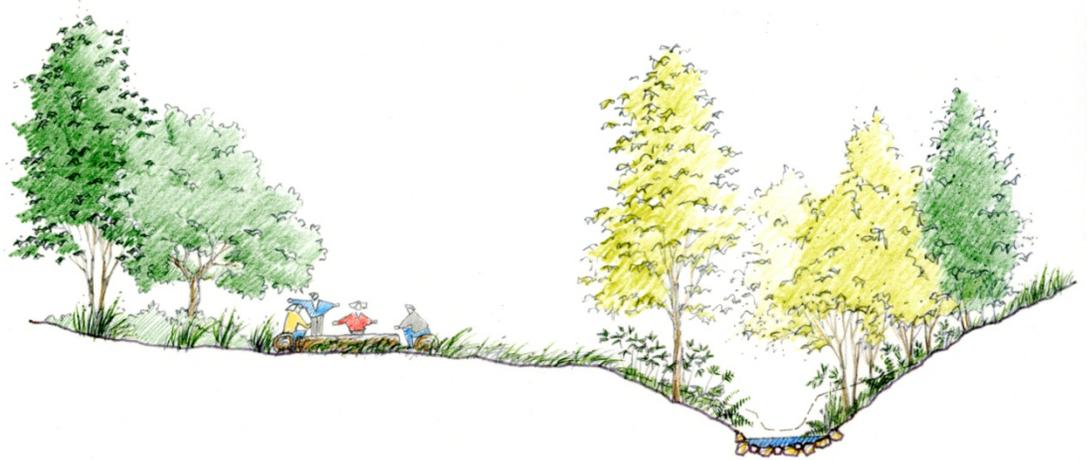
The headcuts, incised reaches, and loss of channel definition indicate that Cottonwood Creek is out of equilibrium. The strategy for restoration in Beaconsfield Canyons should be to recreate an equilibrium condition that transports sediment through the system and stabilizes the creek allowing for long-term establishment of riparian vegetation.

Restoration design should also accommodate a trail and outdoor classroom at the site. Plan view depiction is attached to the end of this document.

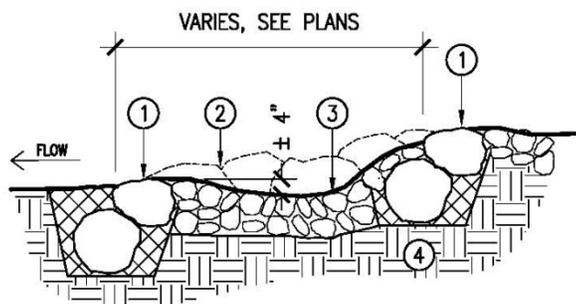
Step-pool restoration design detail

- ① GRADE CONTROL, TOP OF GRADE CONTROL TO MATCH DESIGN CHANNEL ELEVATION AT CENTERLINE. SEE GRADE CONTROL DETAIL FOR ROCK SIZING, KEYING AND REQUIRED SIDE SLOPE TOWARDS CHANNEL.
- ② TOE ROCK WITH POLES, INTEGRATE WITH GRADE CONTROL ROCK AT CHANNEL EDGE, PER O.R. DIRECTION IN FIELD.
- ③ STEP-POOL COBBLE, 16" MIN. DEPTH.
- ④ SUBGRADE

In its equilibrium form, a creek with a gradient of 6.4% or 6.8% will most likely organize itself into a step-pool sequence. Step-pools channels have "steps" comprised of wood, roots, rocks, bedrock, or other clasts with intervening pools filled with finer grain

Examples of restored step-pools can be found nearby on Baxter Creek at Pointsett Park in El Cerrito and East Alamo Creek near San Ramon. Restoration efforts have used rocks, buried logs, and combinations of materials. Step-pool restoration in Beaconsfield Canyon would most likely use logs and rock material to create and anchor the initial steps.

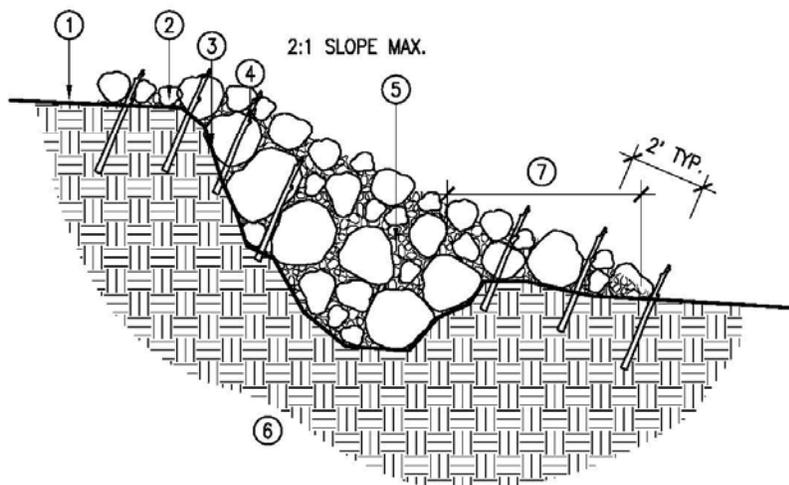
Soil Bioengineering Detail

| ① ACTIVE CHANNEL, F.G. | ⑤ BASE COURSE FILL IN VOIDS. |
| ② SELECT RIPRAP | ⑥ COMPACTED SUBGRADE |
| ③ (E) HEADCUT | ⑦ EXTEND ROCK DOWNSTREAM 5'-0"

BEYOND EXISTING HEADCUT |

| ④ SHORT POLES. MIN.

(.5) POLES PER SF. | |

Soil bioengineering employs live plant materials, often fast growing plants like willows, to control erosion, stabilize stream banks, and provide wildlife habitat.

The planting strategy will be to secure and stabilize the creek channel with relatively fast-growing black cottonwood and willow and augment these with a diverse assemblage of native riparian trees and understory plants. The roots of the willow and black cottonwood will form a sort of vegetative “sling” beneath the stream channel, providing long-term stability.

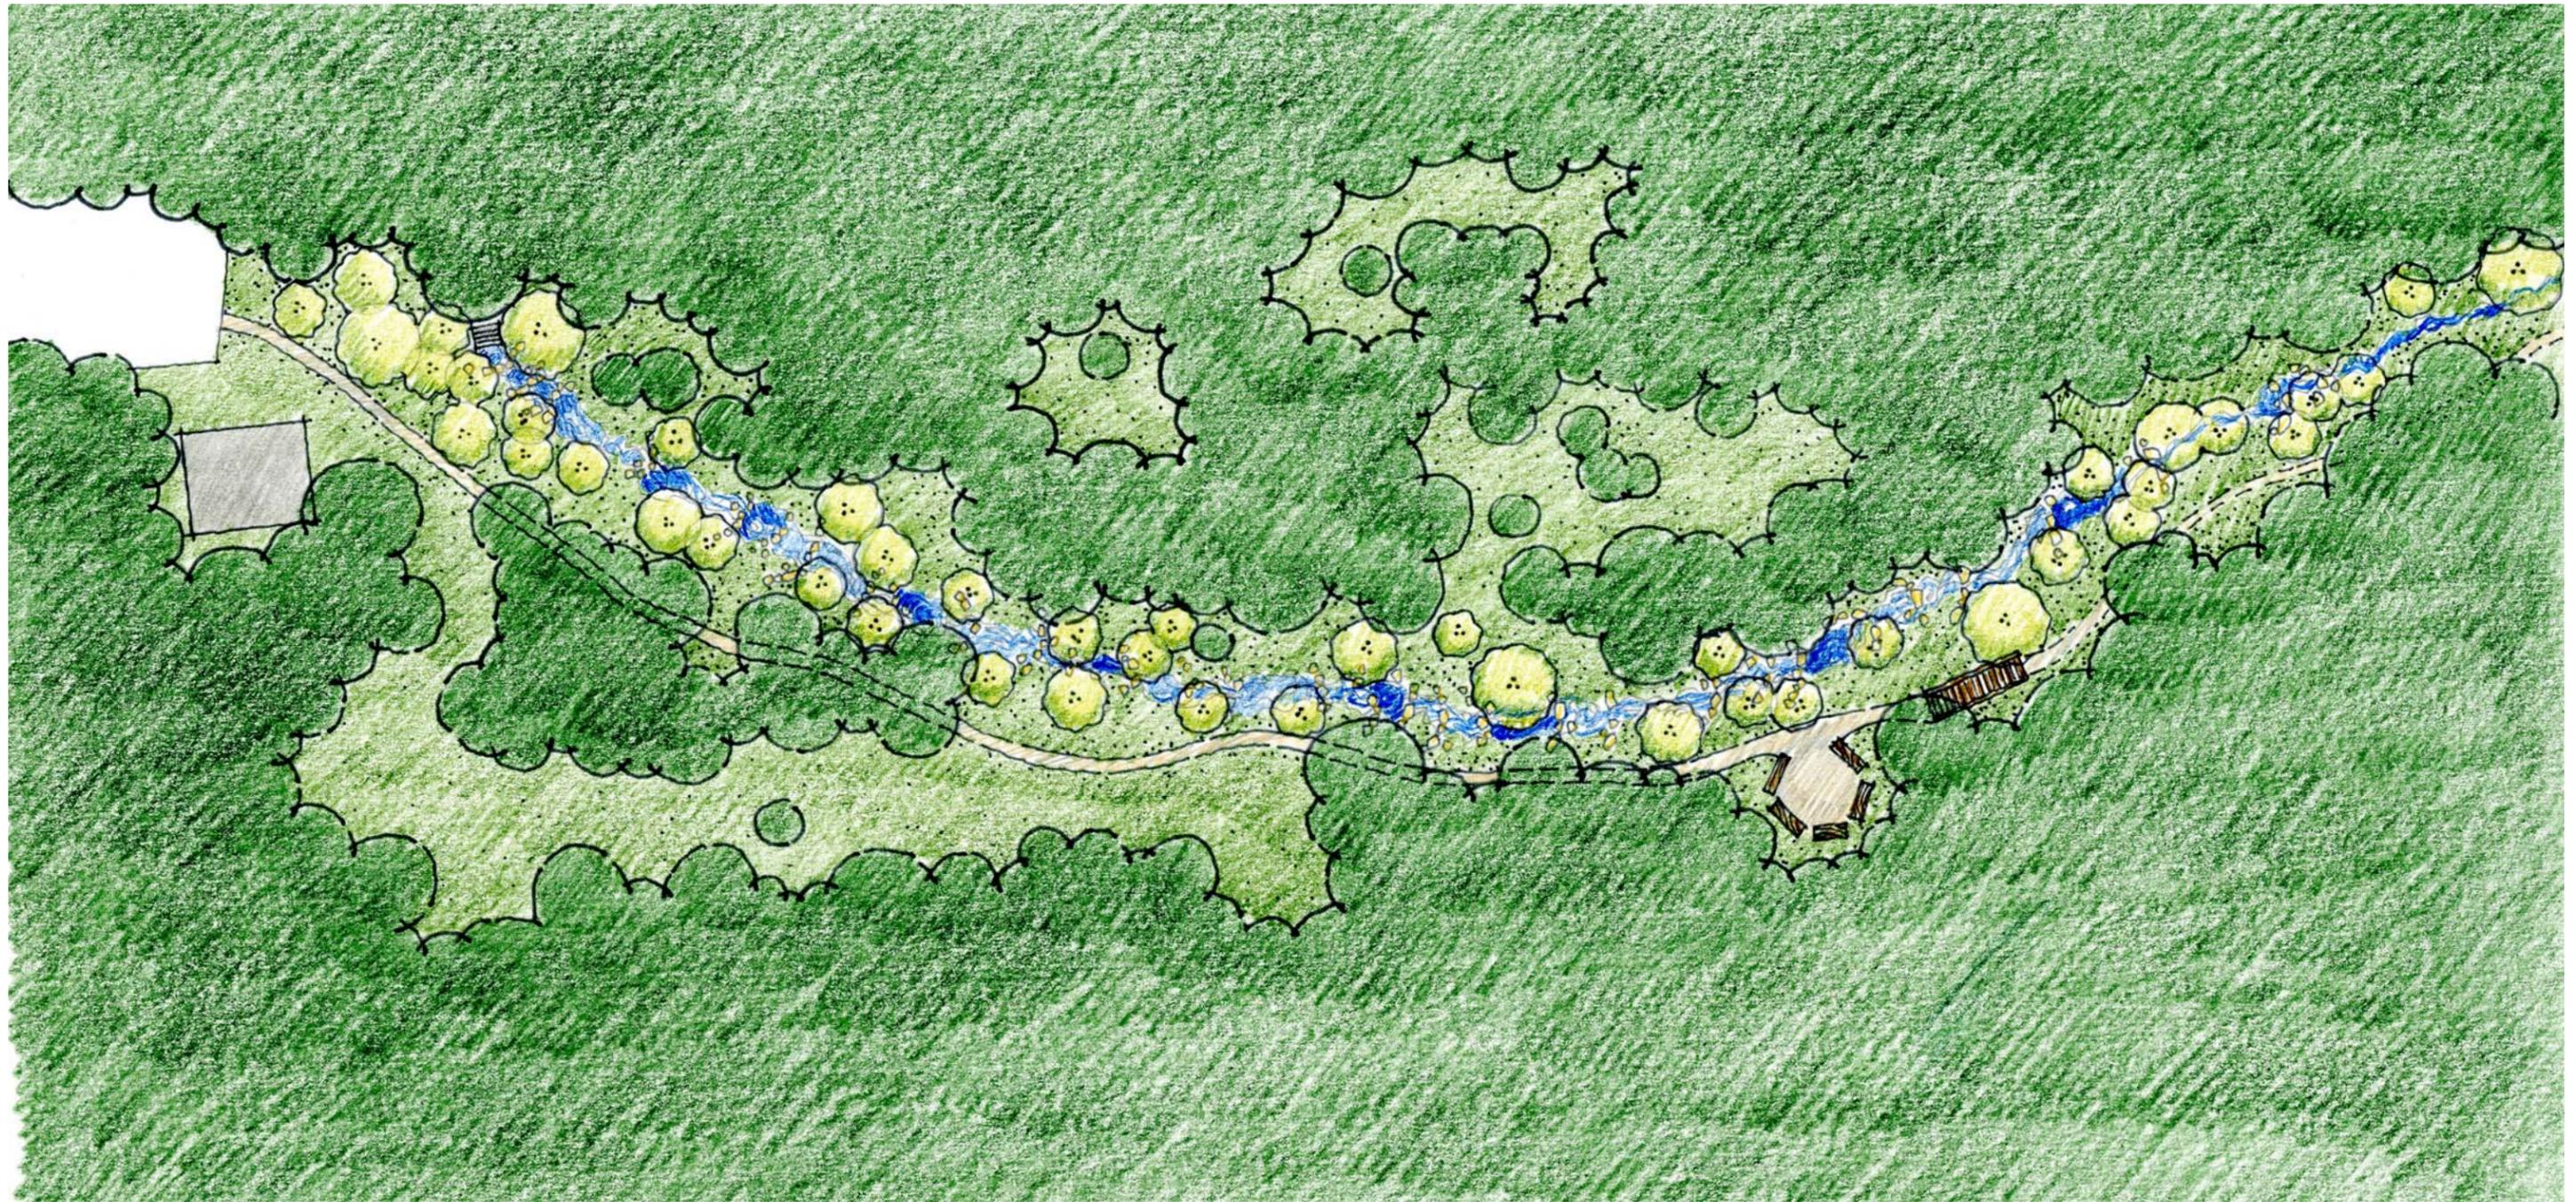
Plan View

Beaconsfield Canyon Conceptual Restoration Design
