**An Assessment of Trails, Watercourses, Soils, and Redwood  
Forest Health in Joaquin Miller Park, Oakland, California,  
with Recommendations for Management**

City of Oakland  
Office of Parks and Recreation  
1520 Lakeside Drive  
Oakland, California 94612

Richard D. Koehler and Janet M. Sowers  
William Lettis & Associates, Inc.  
1777 Botelho Dr., Suite 262  
Walnut Creek, CA 94596

December 31, 2000

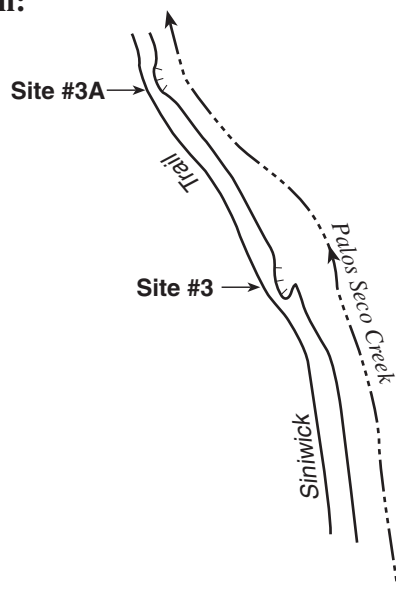
**Sketch:**

**Type of erosion feature and description:** Both feature #03 and #03A are bank failures caused by high flows on Palo Seco Creek, possibly enhanced by ground water seepage into the creek from beneath the trail.

**Potential mitigation:** Bank retention structures could be built to minimize bank erosion and maintain trail width. Possible retention structures include rebar stakes and lumber (see below), boulders placed in eroded void, or timber crib walls.
